Superfund 3rd Five-Year Review Report Smith's Farm Landfill Brooks, Bullitt County, Kentucky

Smith's Farm Landfill
5-Year Review Final Report
September 2006

Third Five-Year Review Report

**Smith's Farm Landfill
Brooks, Bullitt County, Kentucky
September 2006**

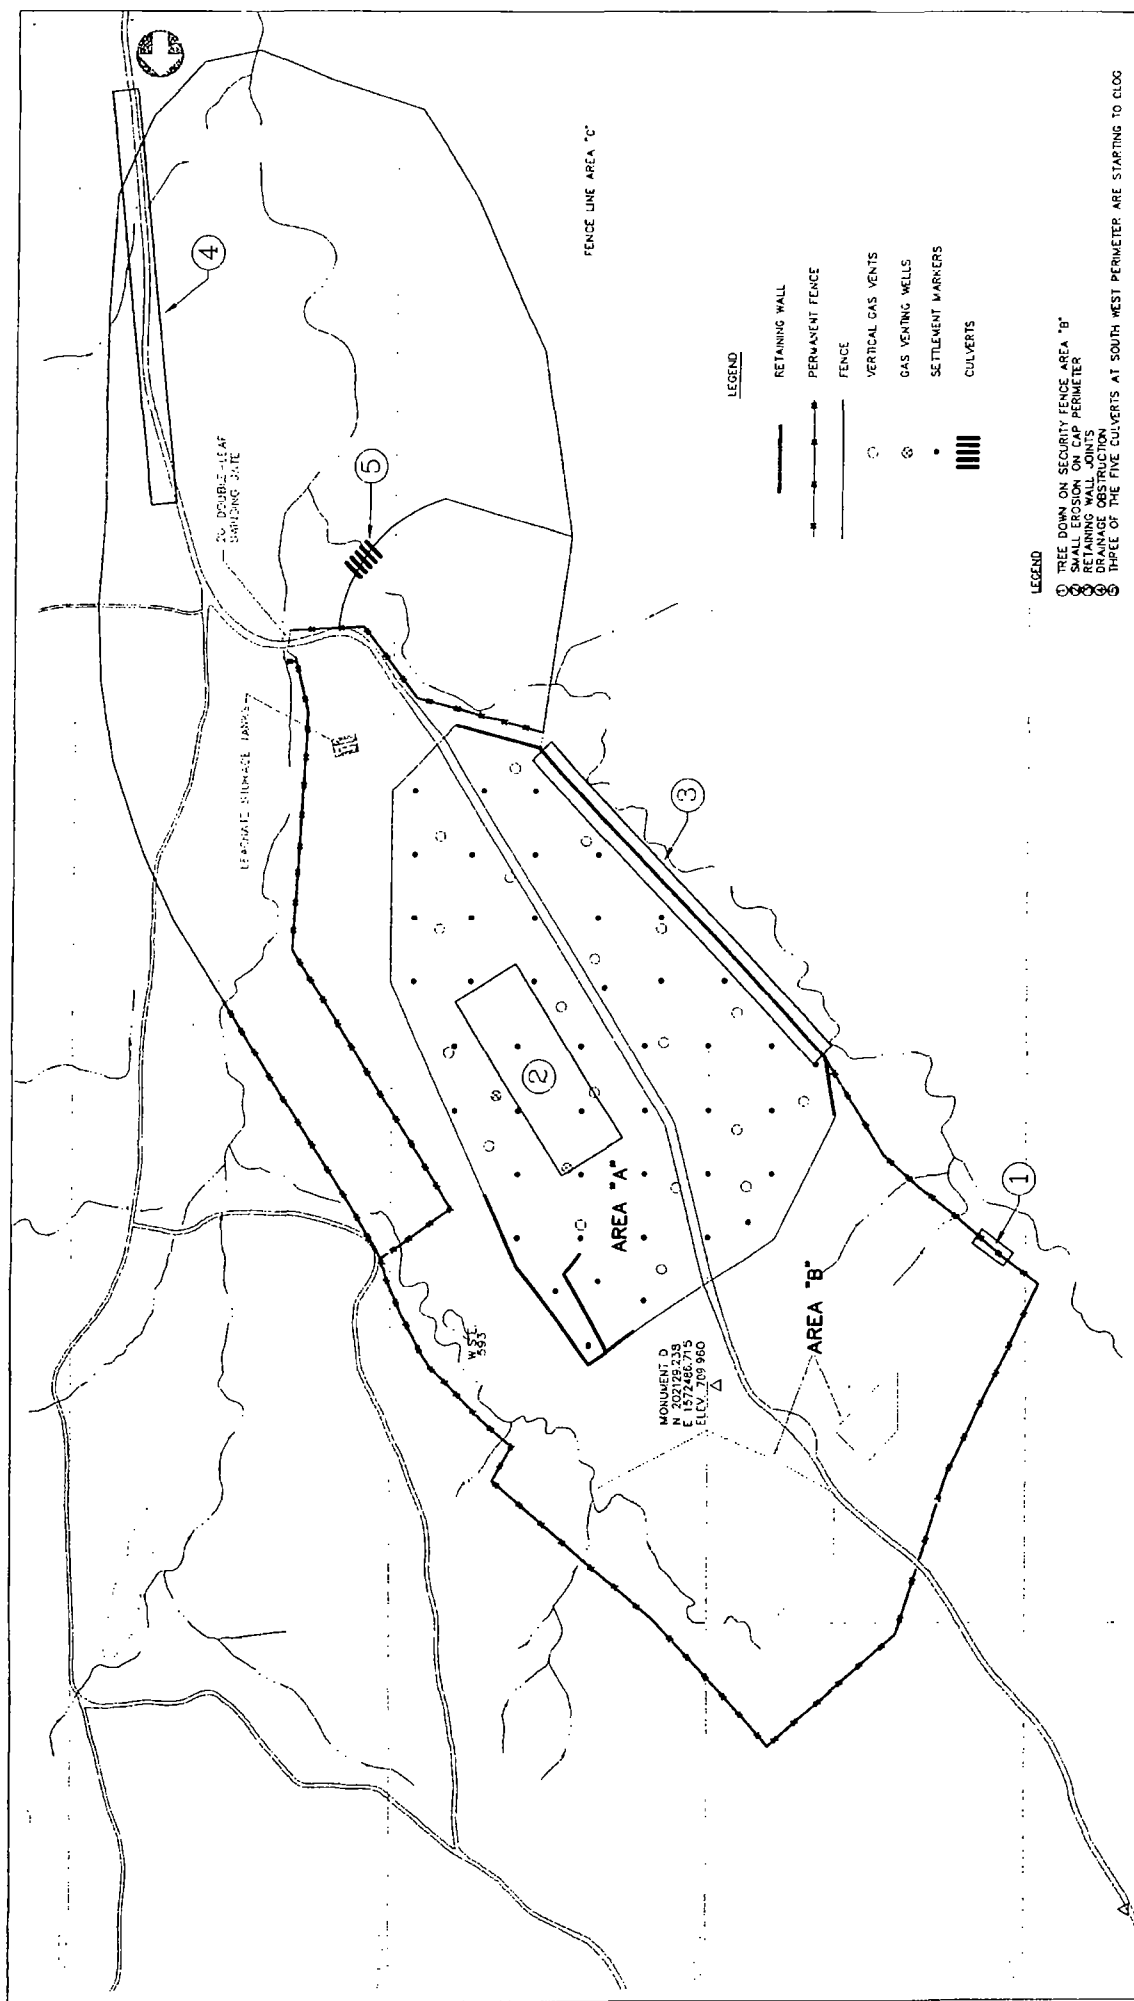
- ① TREE DOWN ON SECURITY FENCE AREA "B"
- ② SMALL EROSION ON CAP PERIMETER
- ③ RETAINING WALL JOINTS
- ④ DRAINAGE OBSTRUCTION
- ⑤ THREE OF THE FIVE CULVERTS AT SOUTH W

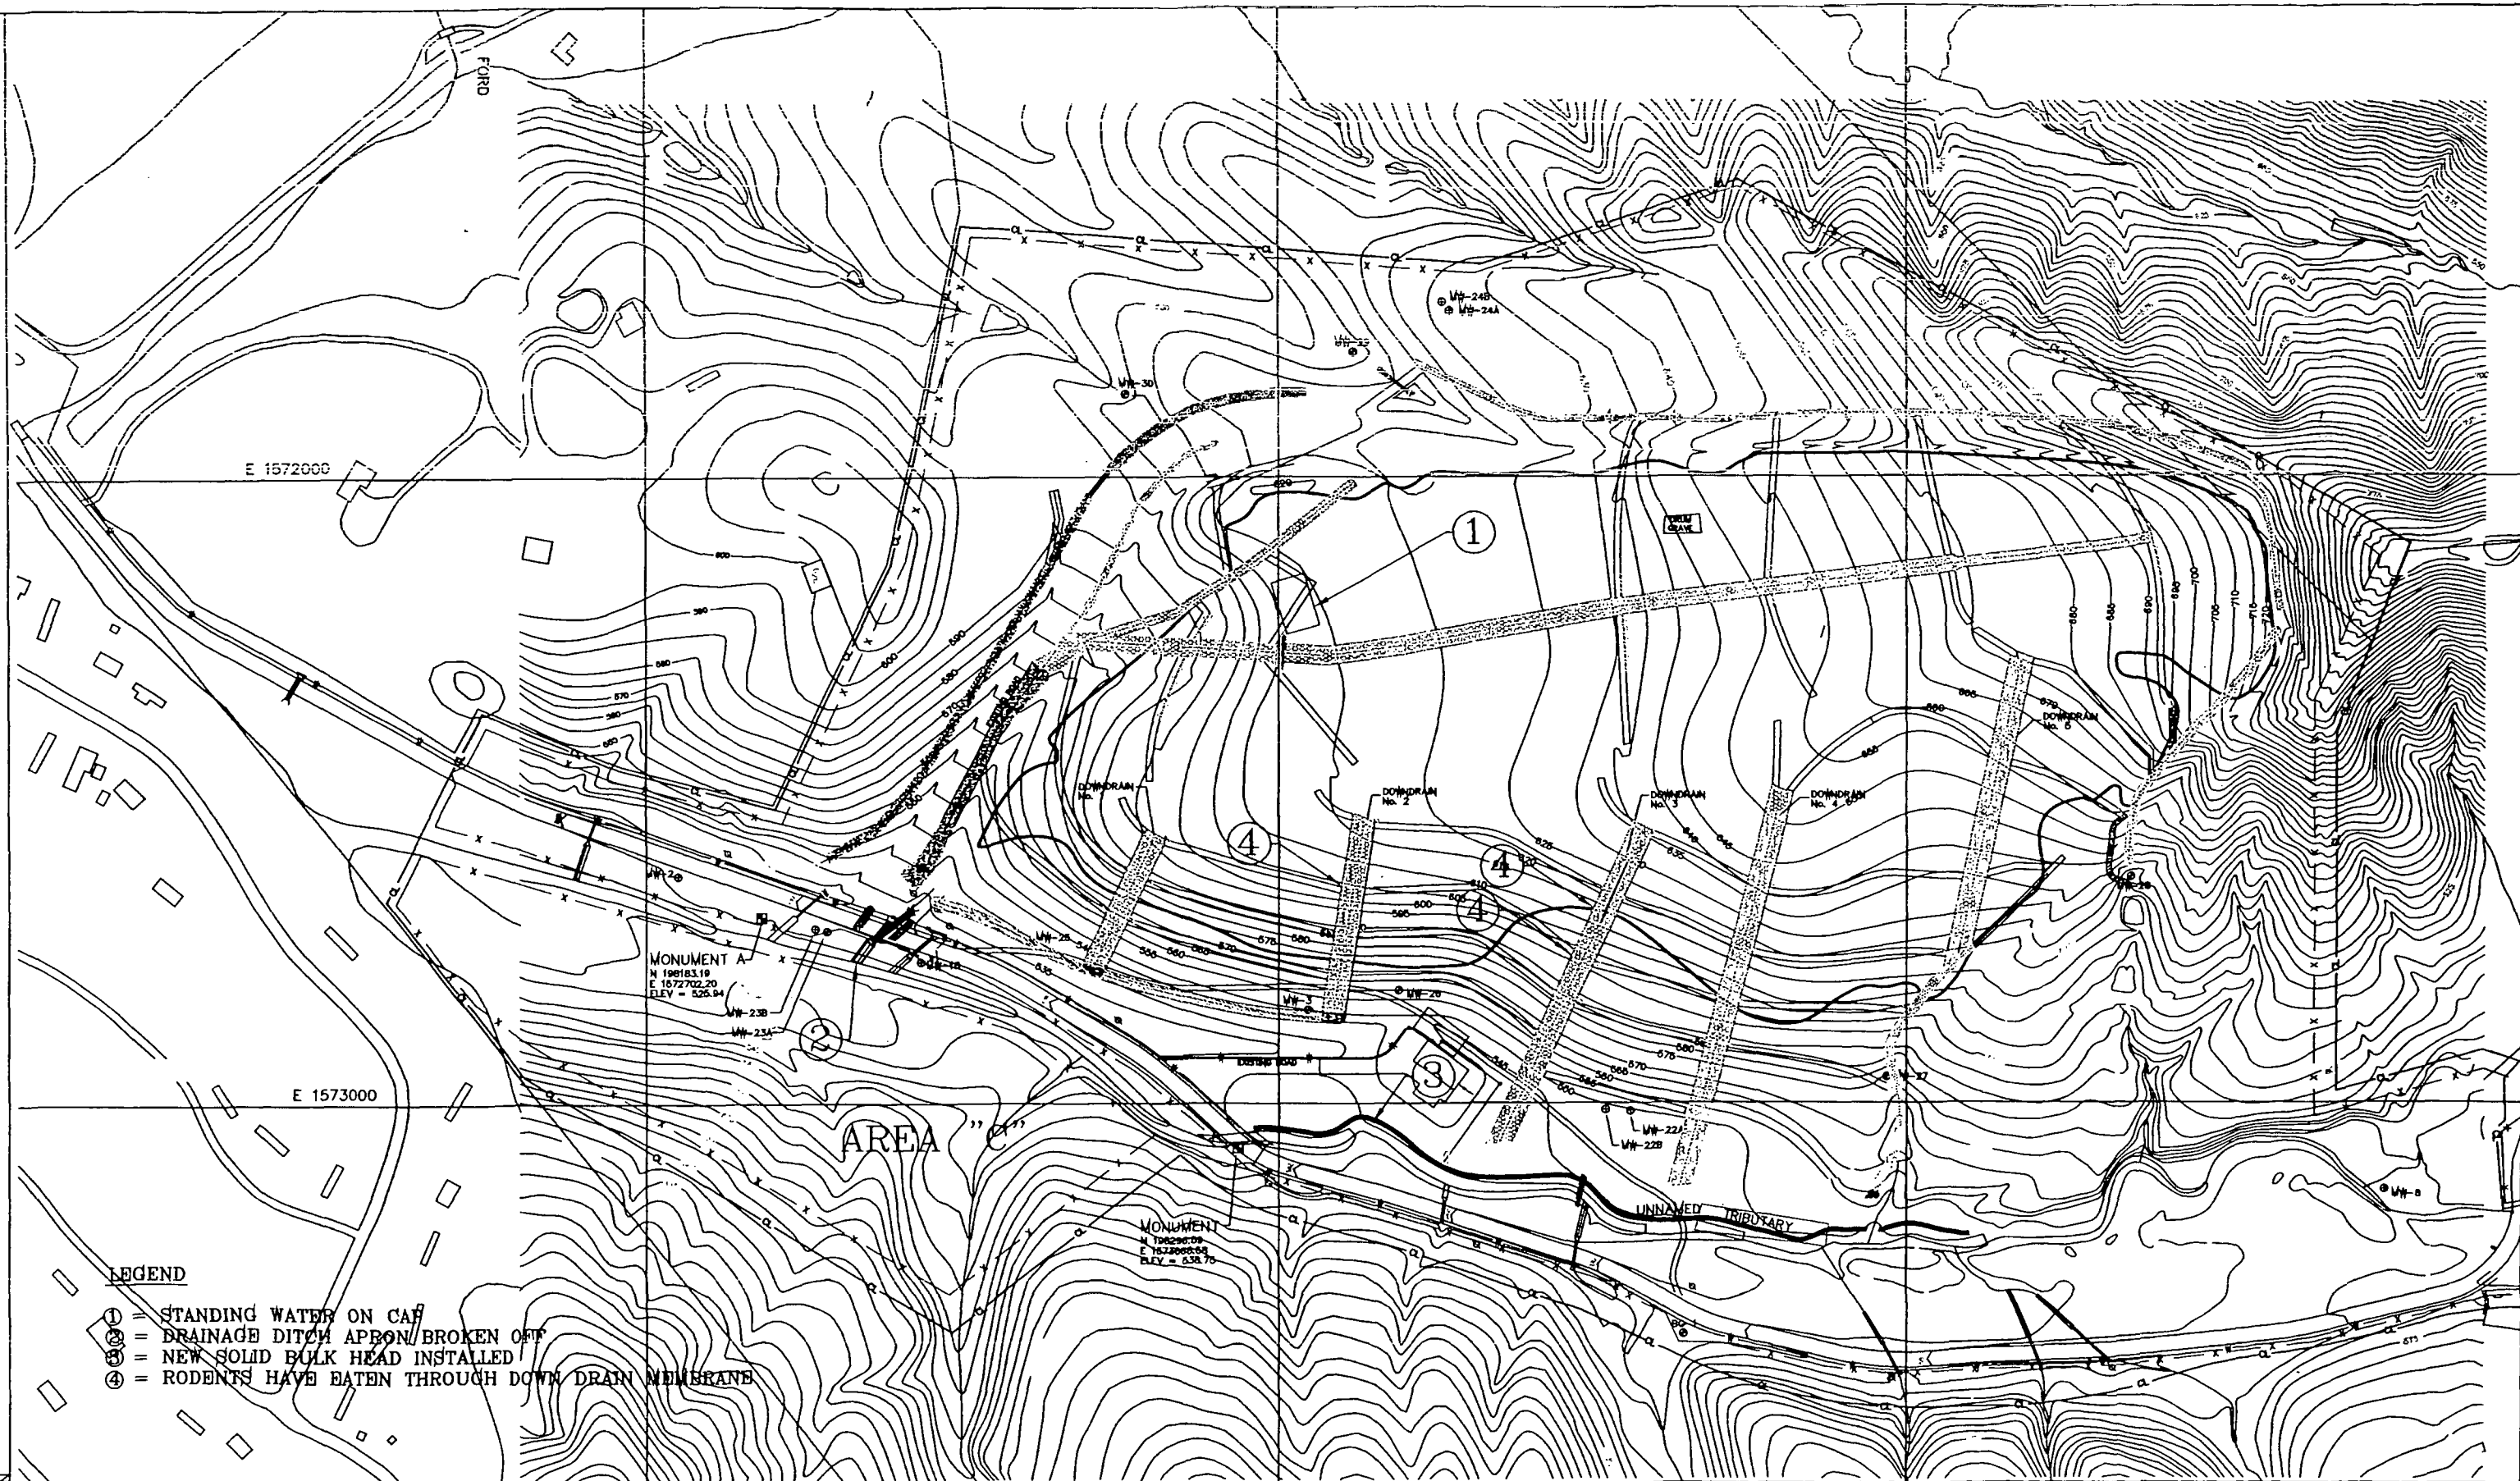
- ① = STANDING WATER ON CAN
- ② = DRAINAGE DITCH APRON BROKEN OFF
- ③ = NEW SOLID BULK HEAD INSTALLED
- ④ = RODENTS HAVE EATEN THROUGH DOWN DRAIN MEMBRANE

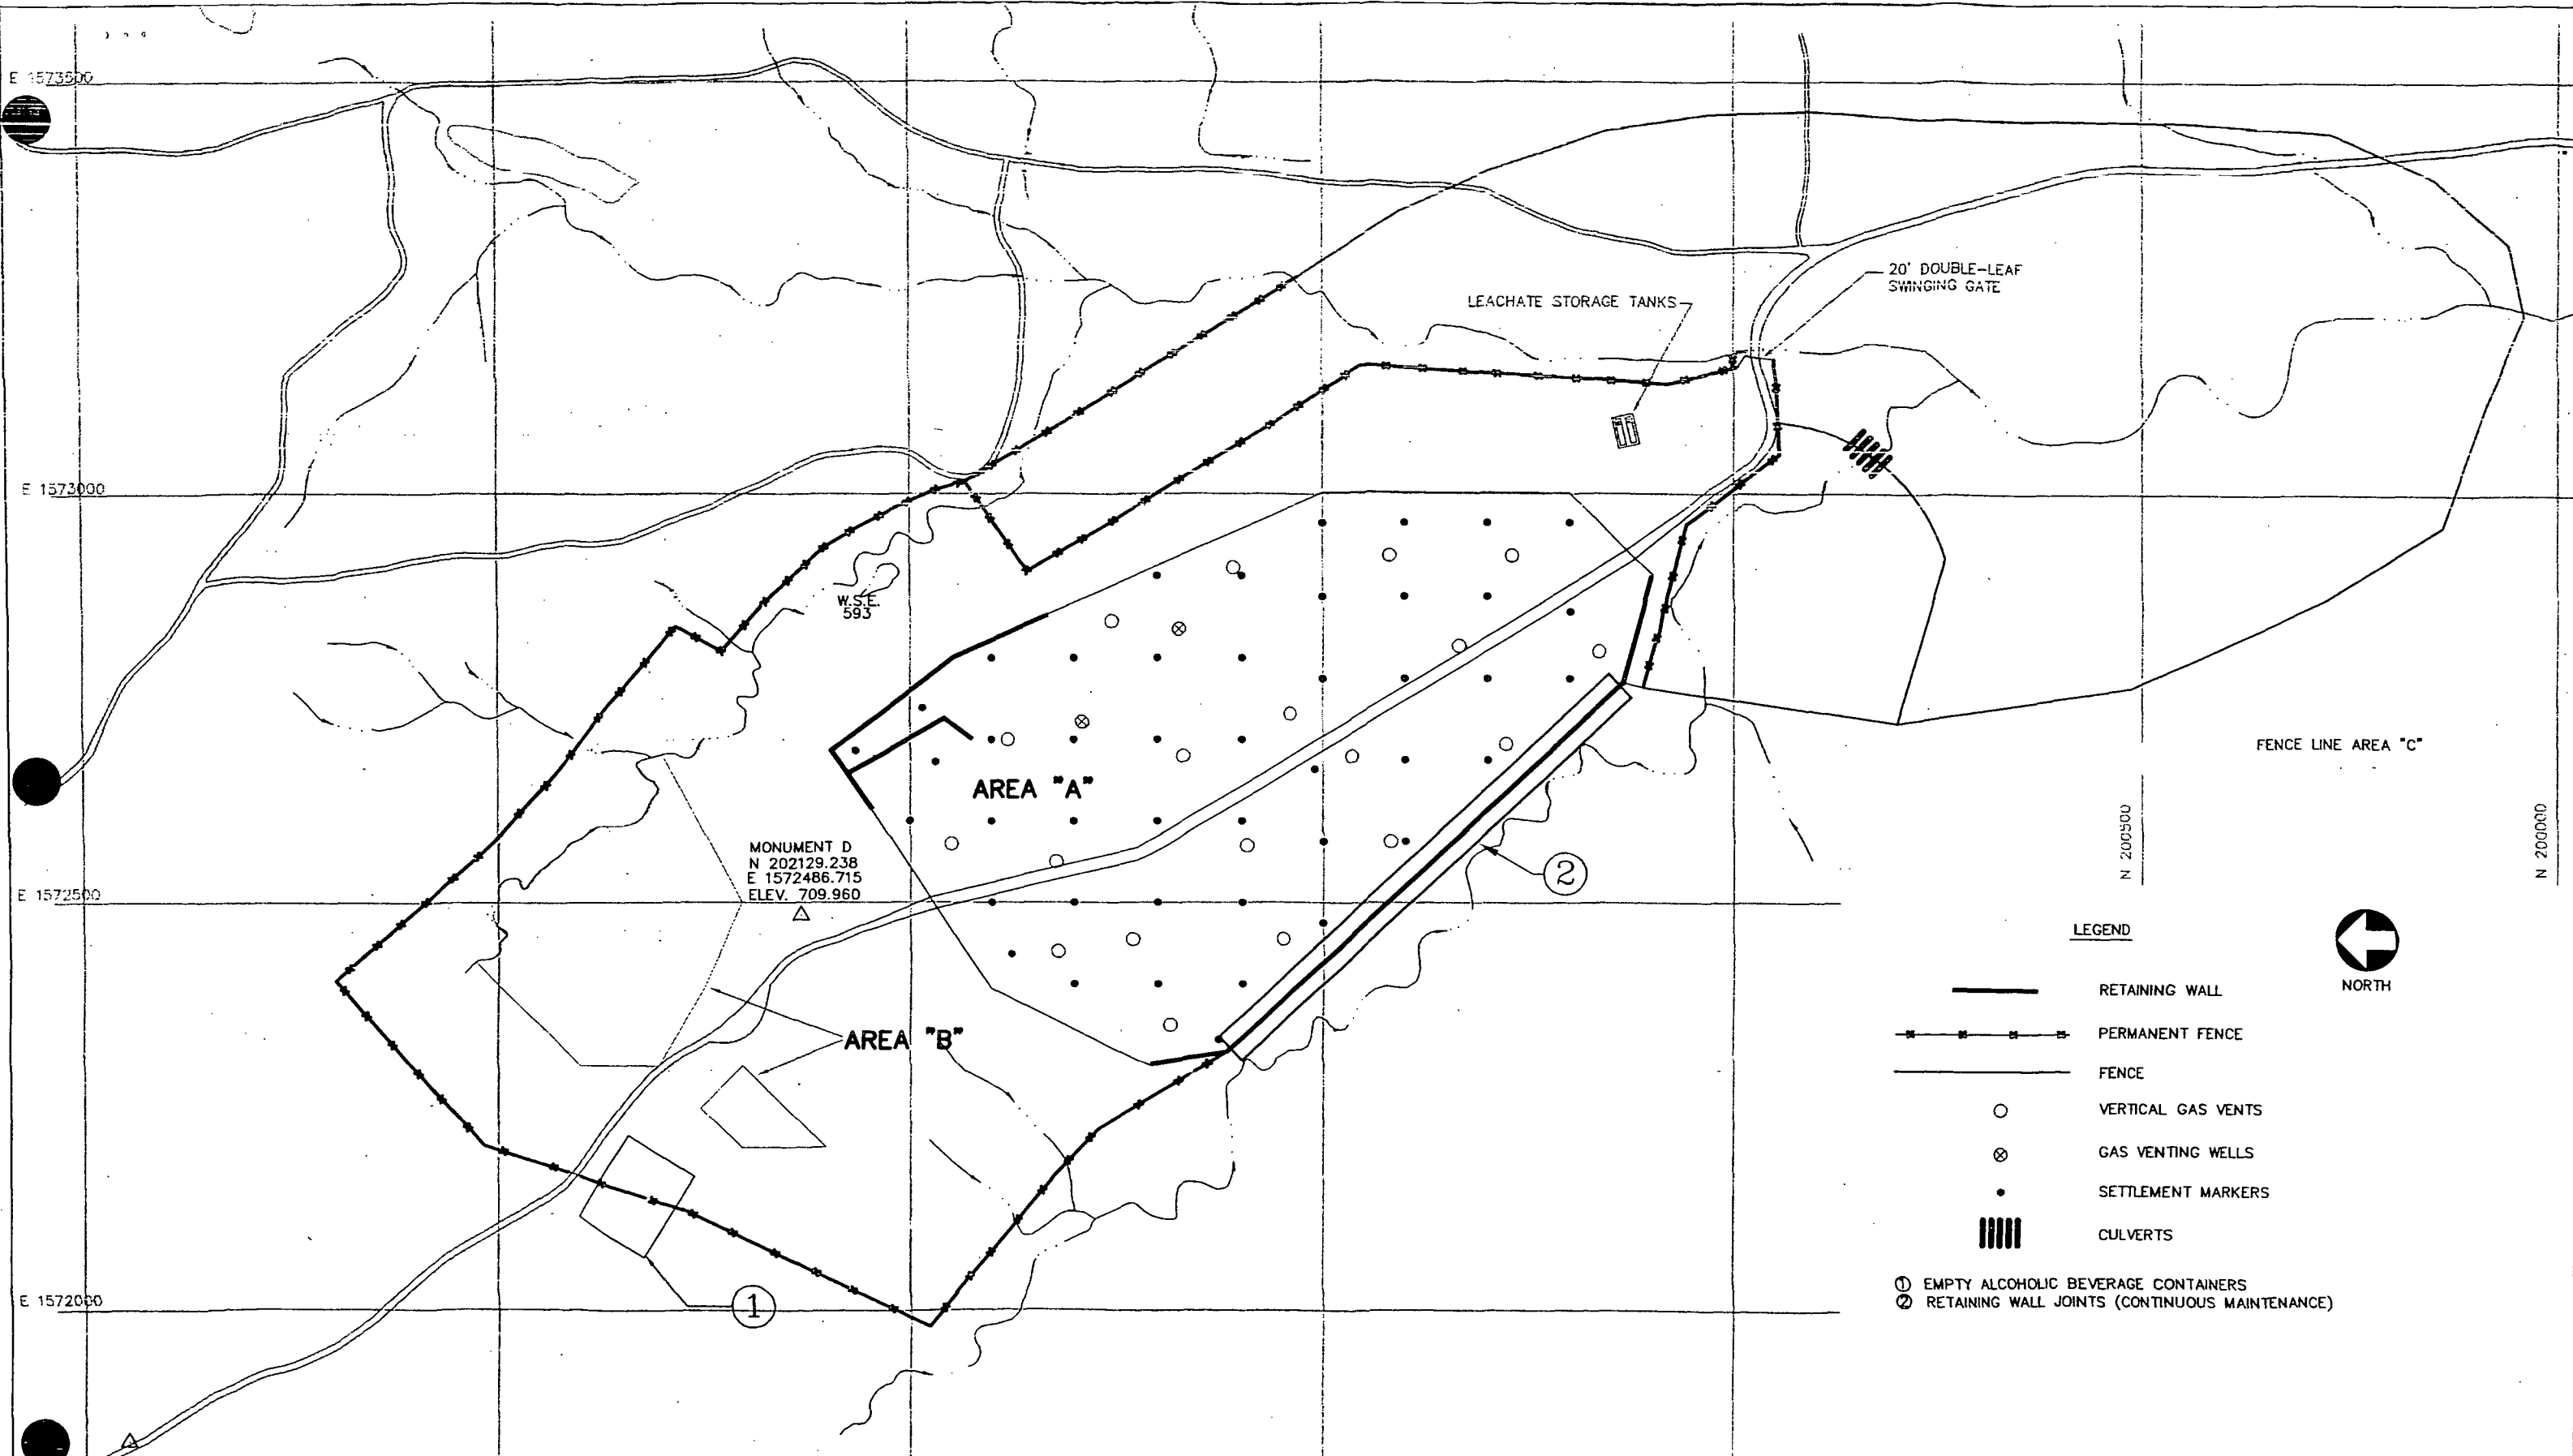
- RETAINING WALL
- PERMANENT FENCE
- FENCE
- VERTICAL GAS VENTS
- GAS VENTING WELLS
- SETTLEMENT MARKERS
- CULVERTS
- ① EMPTY ALCOHOLIC BEVERAGE CONTAINERS
- ② RETAINING WALL JOINTS (CONTINUOUS MAINTENANCE)
